EAST HELENAWATER MASTER PLAN

Prepared for: City of East Helena, MT - April 2018

Prepared by: **Robert Peccia & Associates**Helena, Montana

City of East Helena Water Master Plan

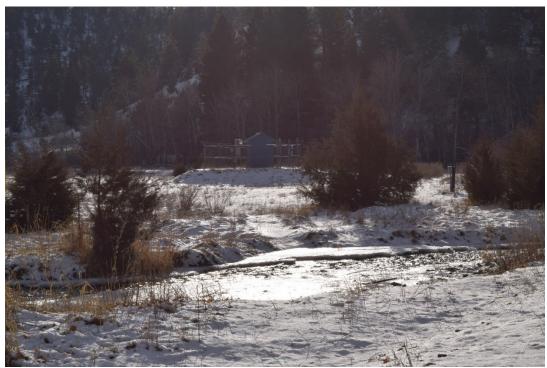
Caisson #2

Each individual caisson is fenced and a metal shed sets over the top of each caisson, however, the majority of the area above these laterals is not fenced. During summer months cattle sometimes graze freely in the area which poses a minor threat to this source. The sheds above each caisson are poorly sealed, and do not prevent rodents or other small creatures from entering.

Caisson Access for Radial Well #2

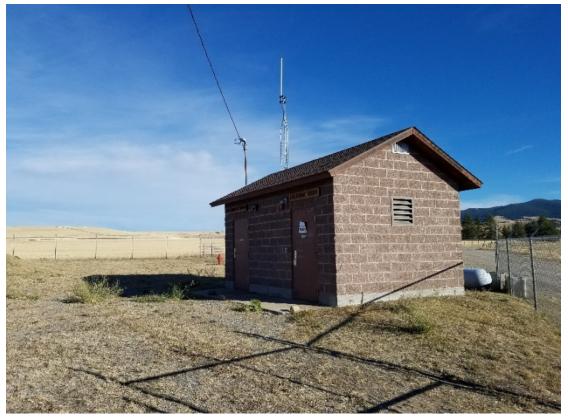
Chlorination Building for McClellan Source

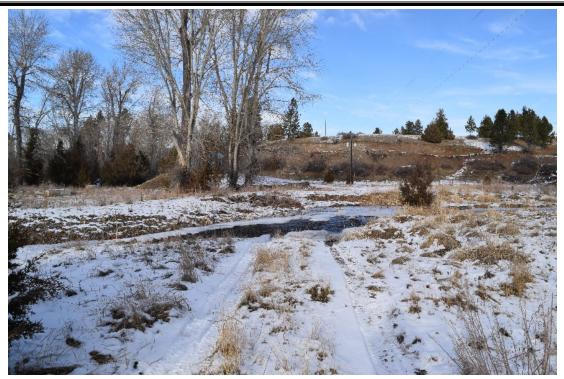
The above problems are exacerbated by the poor access to the radial wells. The access consists of a 2-track dirt road that is impassable much of the winter and during run-off events. City personnel must drive or walk through McClellan Creek to access Radial Well #2 as shown in the photos below. This is unsafe for the City's personnel and causes damage to the creek. These wells are located in a remote area and are not inspected on a regular basis. Improved access for both inspection and maintenance is desirable. See **Figure 2.C.1** for the location of the Radial Wells and ownership of land in the area.

Access Between Radial Well #1 and Radial Well #2 (North)

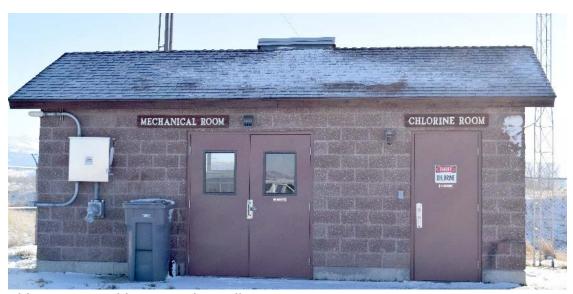
Chlorination for the total output of all three wells occurs adjacent to Wylie Well #3 in the transmission main. Chlorine gas is utilized and the injection tap and the chlorine sampling tap are buried downstream of the building which makes access and maintenance difficult. Originally these items were located in a vault across Wylie Drive from the well building. In 2013, during an MDT roadway construction project, the sampling piping and injection piping were lost. This situation had to be remedied quickly and the injection point was relocated at their current location (with no vault).

Chlorination Building at Wylie Well #3

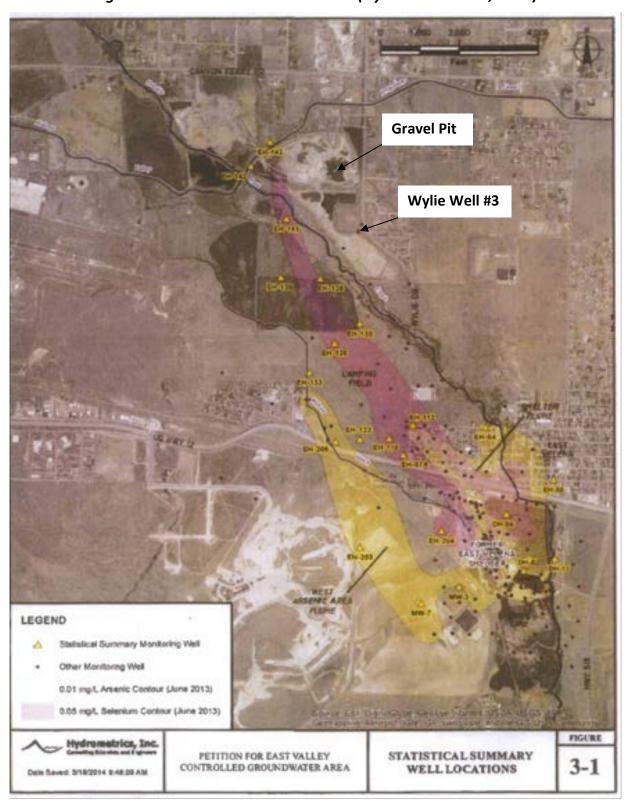
Figure 2.C.2: Contamination Plumes (Hydrometrics Inc., 2014)

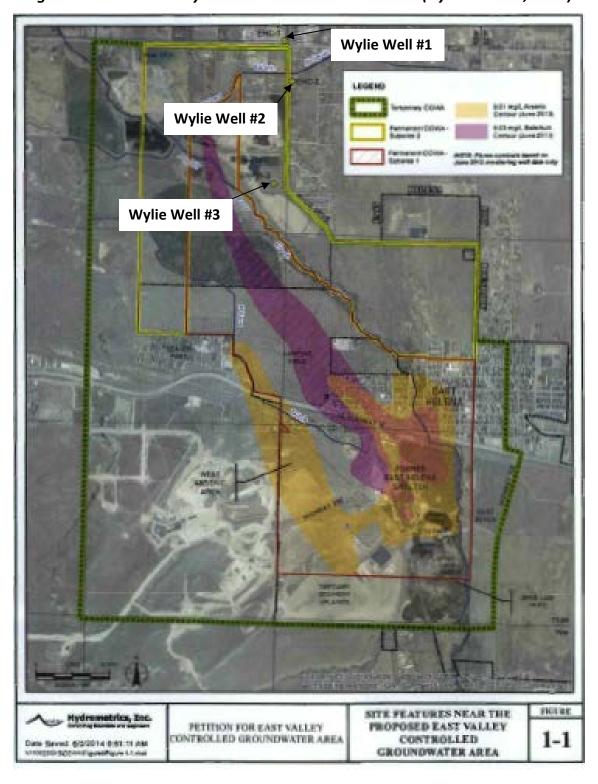
Figure 2.C.3: East Valley Controlled Groundwater Area (Hydrometrics, 2014)

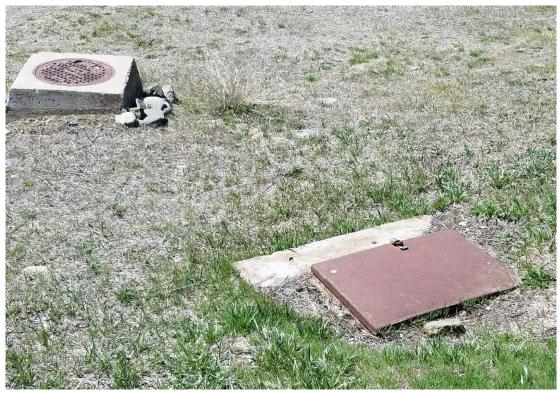
Additionally, the valves and piping (shown in **Figure 2.C.5**) that connect these tanks have been constructed in piece-meal and do not provide the operators methods for control or isolation. The valves for this piping are located in vaults which are approximately 15 to 17-feet in depth. The manhole steps cast into these vaults for access have all but rusted away. Water system operators are not certain which valves are for what purpose (draining, filling, isolation) and which valves and piping has been abandoned. Operators have attempted in the past to isolate one tank from the other unsuccessfully. Either the wrong valves were turned, or these valves do not function (hold).

Vaults at McClellan Tanks

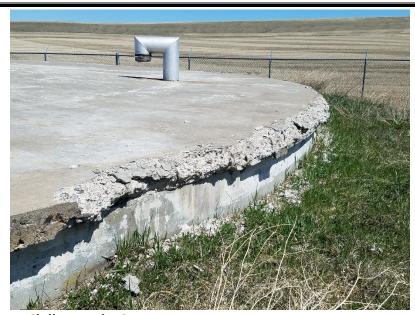
Water levels were read over a 24-hour period and determined there was a 1.82-foot loss in each of the McClellan tanks. This equates to a loss of 17,110 gallons in Tank #1 and 26,734 gallons lost in Tank #2 for a total of 43,844 gallons of water lost within a 24-hour period (calculations shown in **Appendix I**). This amount is much greater than the allowable leakage rate suggested by ACI.

McClellan Tank #2

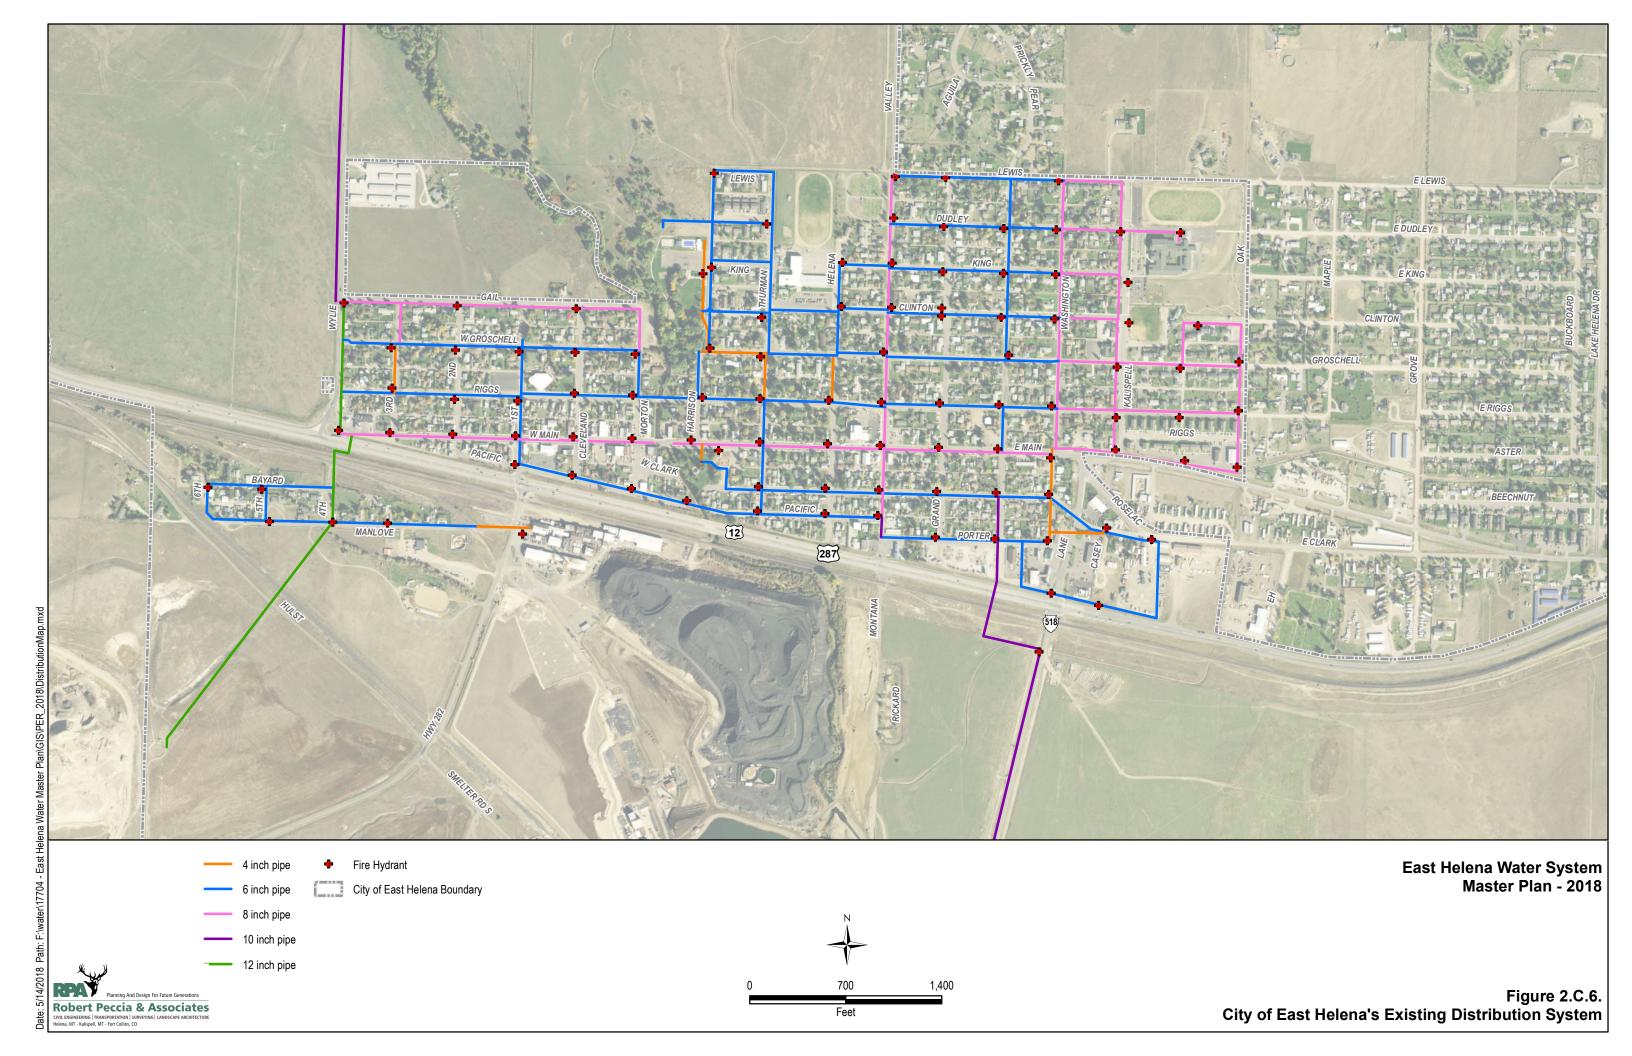
The City's distribution system is a network of mains ranging in size from 4-inch to 8-inch. **Figure 2.C.6** shows the City of East Helena's existing water distribution network and **Table 2.C.10** summarizes the sizes and estimated lengths of distribution piping. In 1999, the City replaced approximately 16,760 feet of water main within the City due to age and condition.

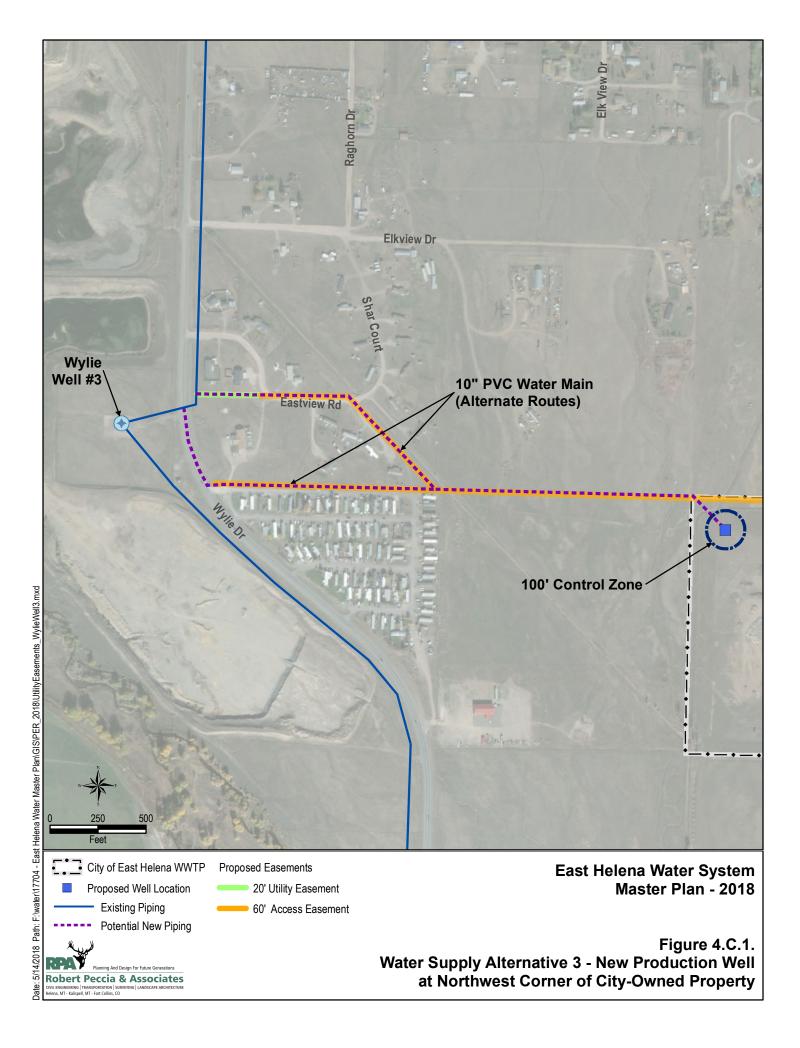
Figure 4.C.1 shows the location of the new well located in the northwest corner of the City's property.

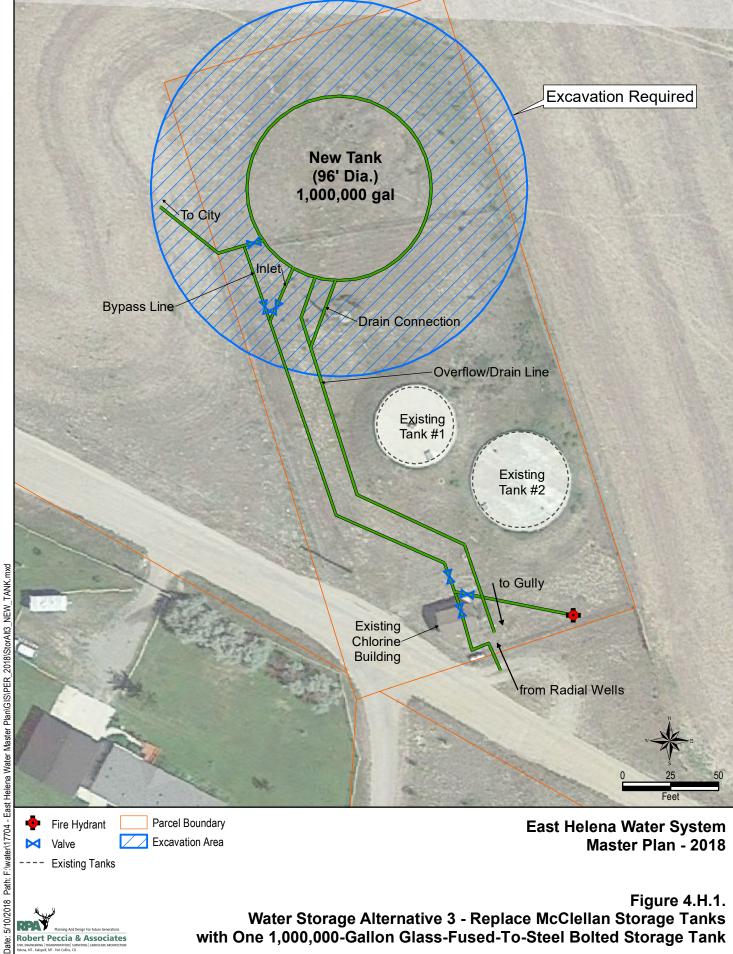
Water Storage Alternative 3 - Replace McClellan Storage Tanks with One 1,000,000-Gallon Glass-Fused-To-Steel Bolted Storage Tank

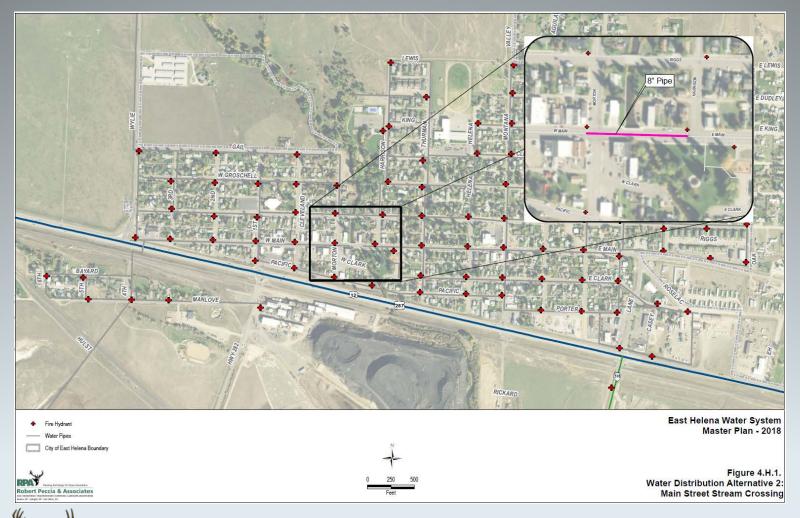
# Preferred Water Distribution System Alternative 2

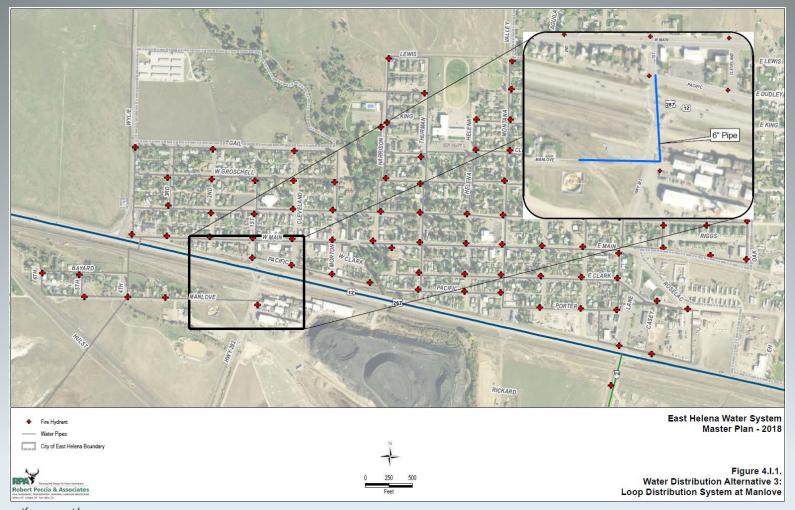
# Preferred Water Distribution System Alternative 3

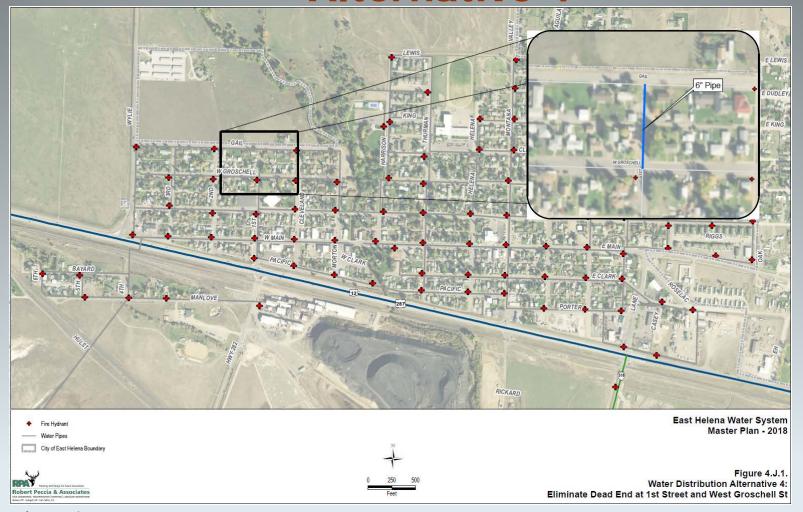
# Preferred Water Distribution System Alternative 4

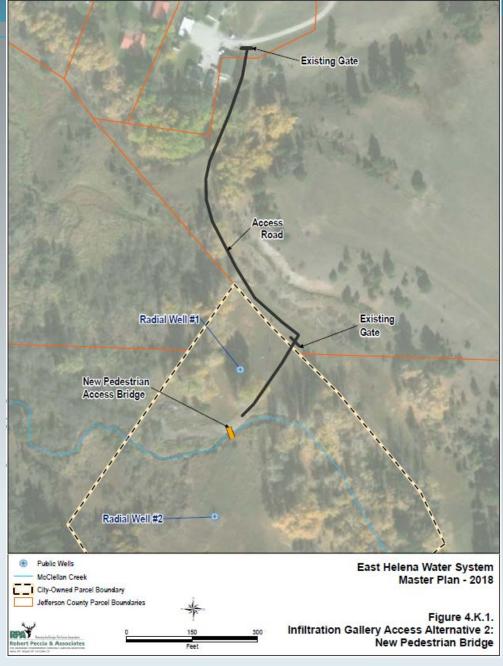
# Preferred McClellan Water Source Access Alternative
